RICHWOODS MINE 'B' MILL DAM

MO. 31404

**PHASE 1 INSPECTION REPORT
NATIONAL DAM SAFETY INSPECTION**

SEPTEMBER 1980

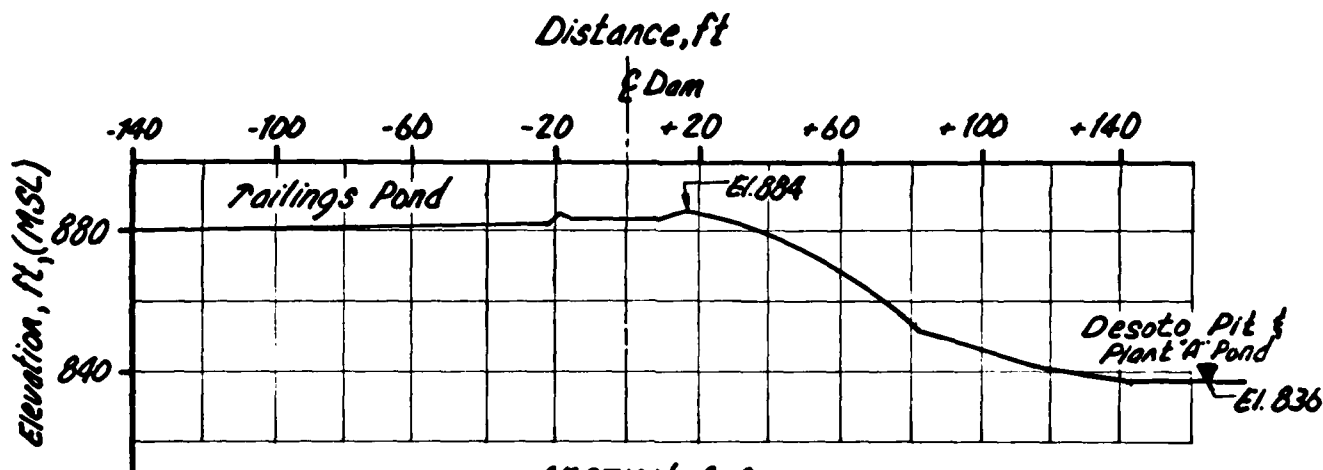
SECTION A-A
Maximum Cross-Section

- a. General. Dam was inspected on 3 June 1980 without the owner's representative present. This inspection indicated the dam is in an unsatisfactory condition.
- b. Dam. The Richwoods Mine B Mill Dam consists of coarse tailings locally referred to as "chat". This material is sandy gravel and sand (GW, SW). It is cohesionless and can be easily eroded. The material is end-dumped on the crest of the dam by trucks. Compaction is limited to truck traffic. Slopes on the dam generally are at the angle of repose for this material, 33 to 35 degrees. A 40 degree slope angle was measured on portions of the maximum section (Fig. 3B).

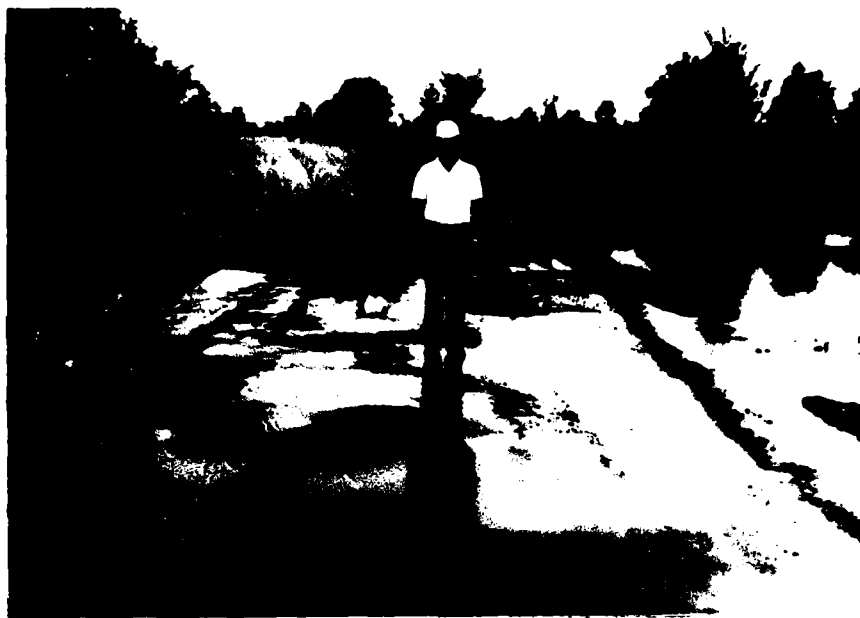
Richwoods Mine B Mill Dam is approximately 3700 ft long and borders the impoundment area on the north, east and south. It is approximately 48 ft high at the maximum section. There is no designed spillway for this dam. A low area at the southwest end of the embankment acts as an informal spillway. An 8 in. diameter pipe crosses beneath the road along the south side of the reservoir and is the only outlet structure identified. The pipe has corroded to the point of being inoperative. Some overflow from the reservoir flows across the road at approximately the same location as the pipe. The lowest point controlling overflow is elevation 872 ft MSL on the road (see Photo 7). Elevations on the dam crest vary from 884 ft to 872 ft MSL.

No maintenance is apparently performed on the operating facilities. The outlet pipe buried under the overflow section of the embankment has deteriorated through corrosion to the point of being inoperative.

7. Overflow crossing road. Reservoir to right. Looking west. Discharge pipe in background to right.
